**1<sup>st</sup> Work Report**  
(December 3, 2025 to February 28, 2026)

**Construction of one building holding 2 classrooms, an office,  
storage space, and restrooms  
for the Public Preschool of Kadolassi  
Badjoudè County  
Municipality of Ouaké  
Republic of Benin**

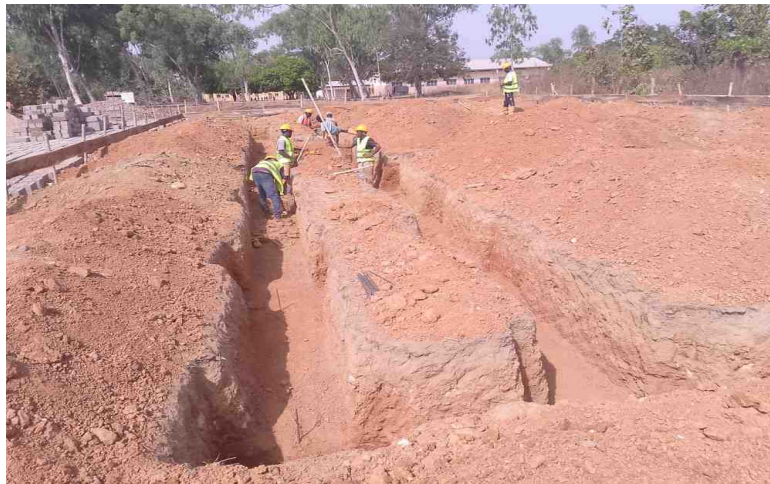
Once the foundation trenches for the building had been dug, the masons widened the areas where the “elephant feet” of the pillars would be placed.

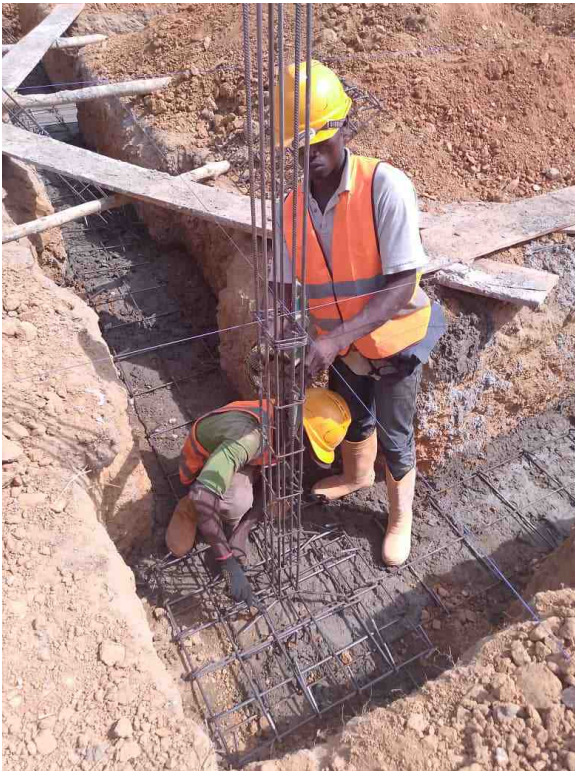
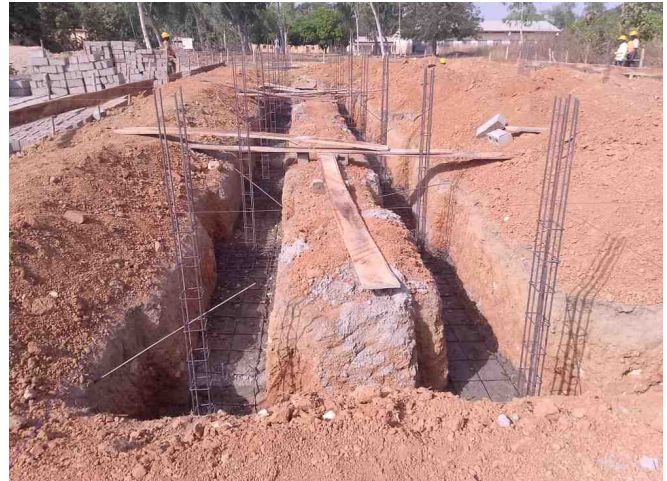
The iron reinforcements for the foundation and pillars were incorporated into the first layer of concrete.

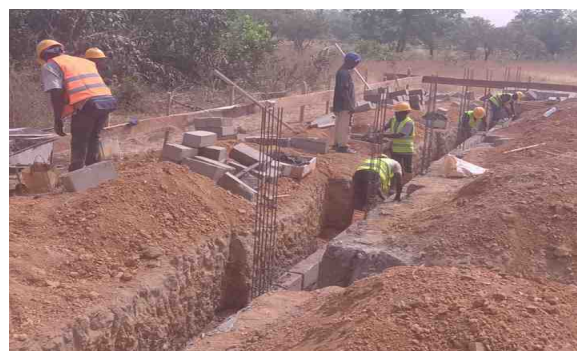
A second layer of concrete was poured over this, and the walls were built on this reinforced foundation.

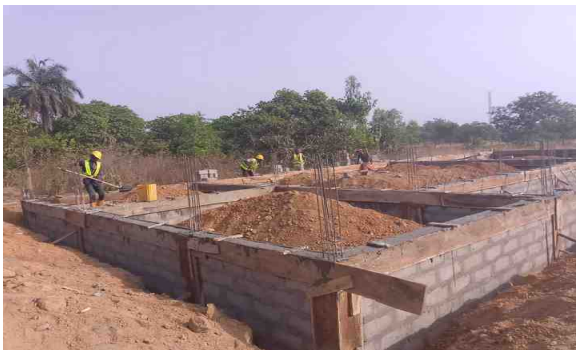
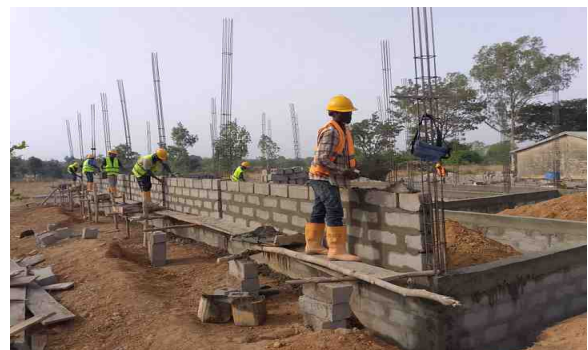
The lower iron anchor was cast, and the walls of the building were erected upon it.

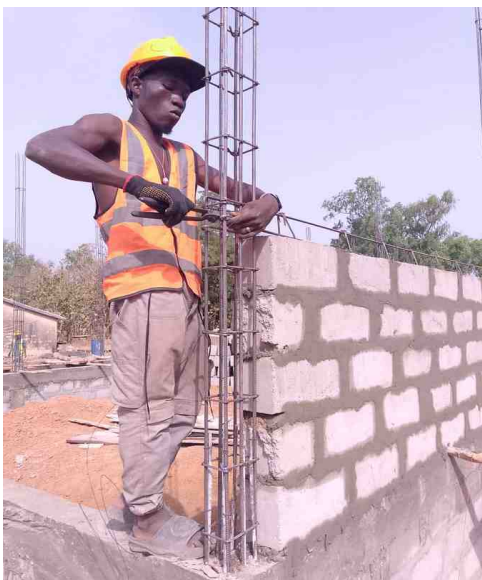
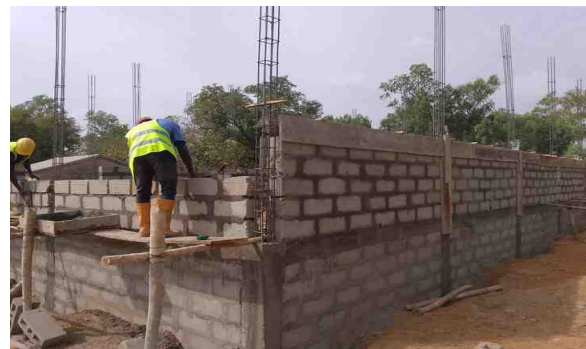
The small iron anchor below the window openings was prepared and cast.

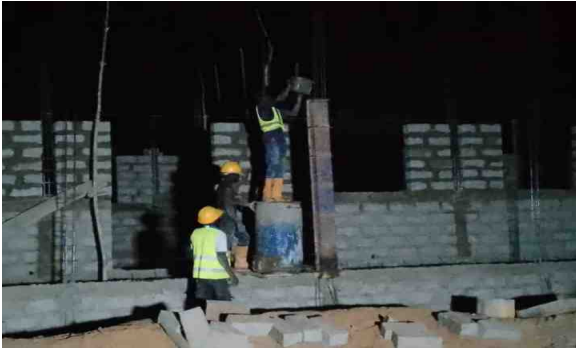
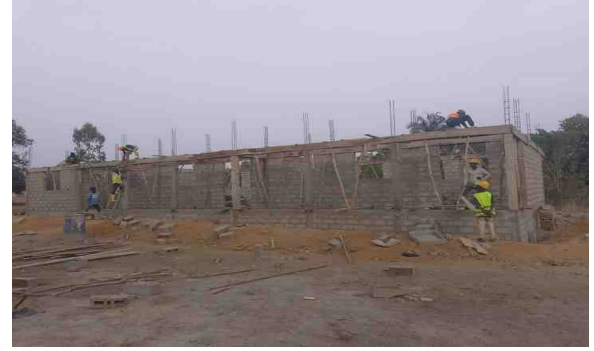
And on we went: The walls soon reached the window lintel. The veranda pillars were cast. Then the upper iron anchor was cast in one piece.

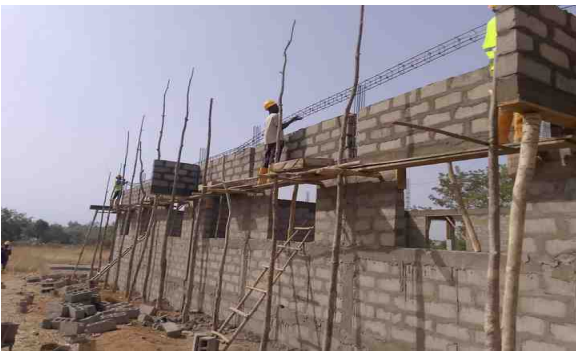
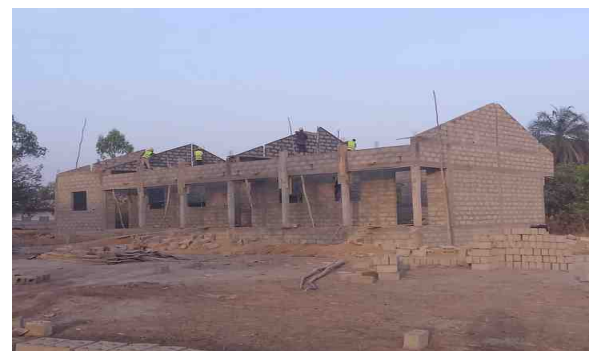
The walls were then raised up to the iron anchor below the roof. The last iron anchor was cast and the gables were erected.

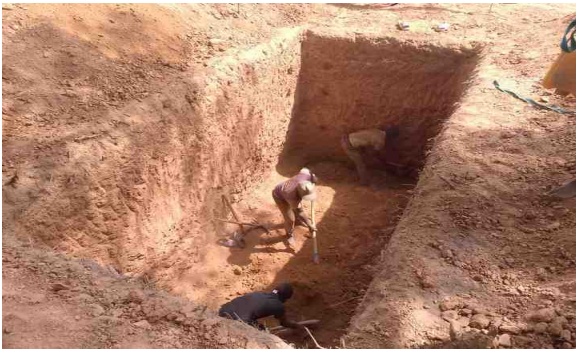
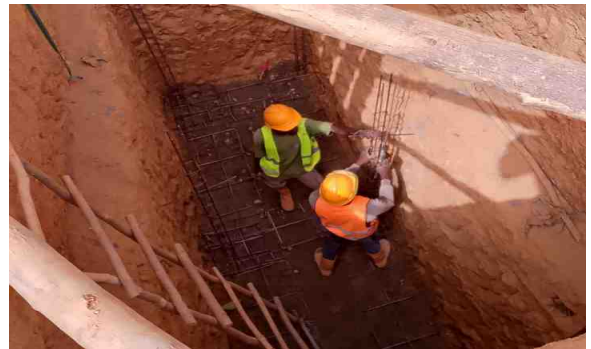
Meanwhile, the toilets were built. After the villagers had dug the toilet pit, the foundation was laid and the iron for the pillars was inserted.

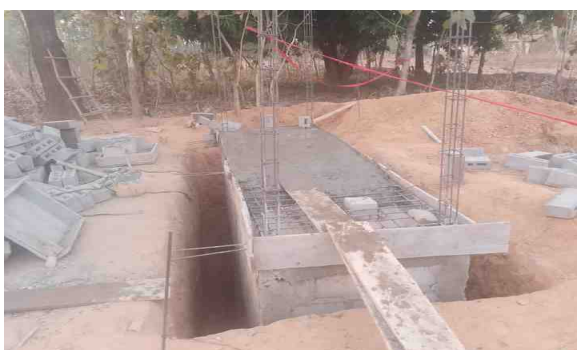
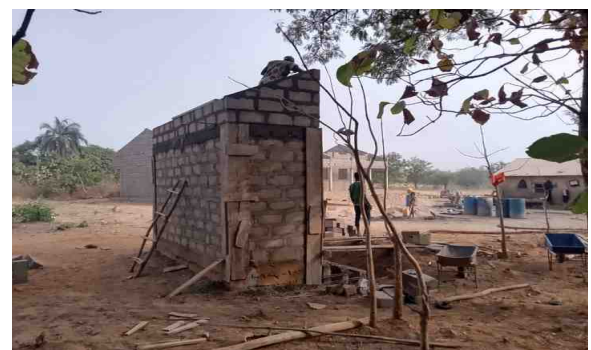
The toilet pit was plastered with Sikalite and Sikalatex. It was then sealed. The cubicles were built on top of it.

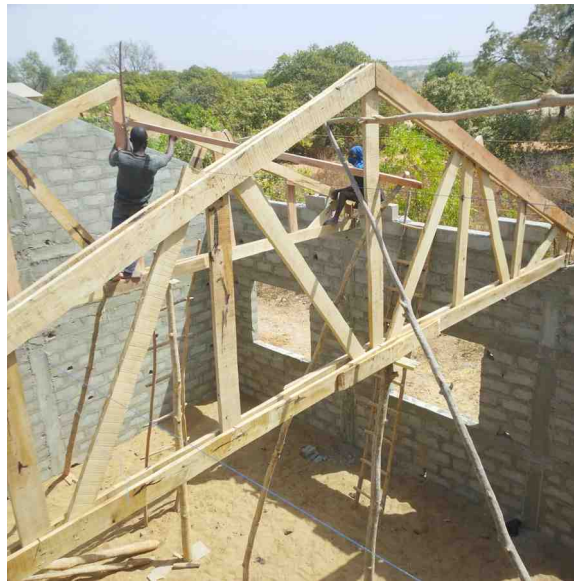
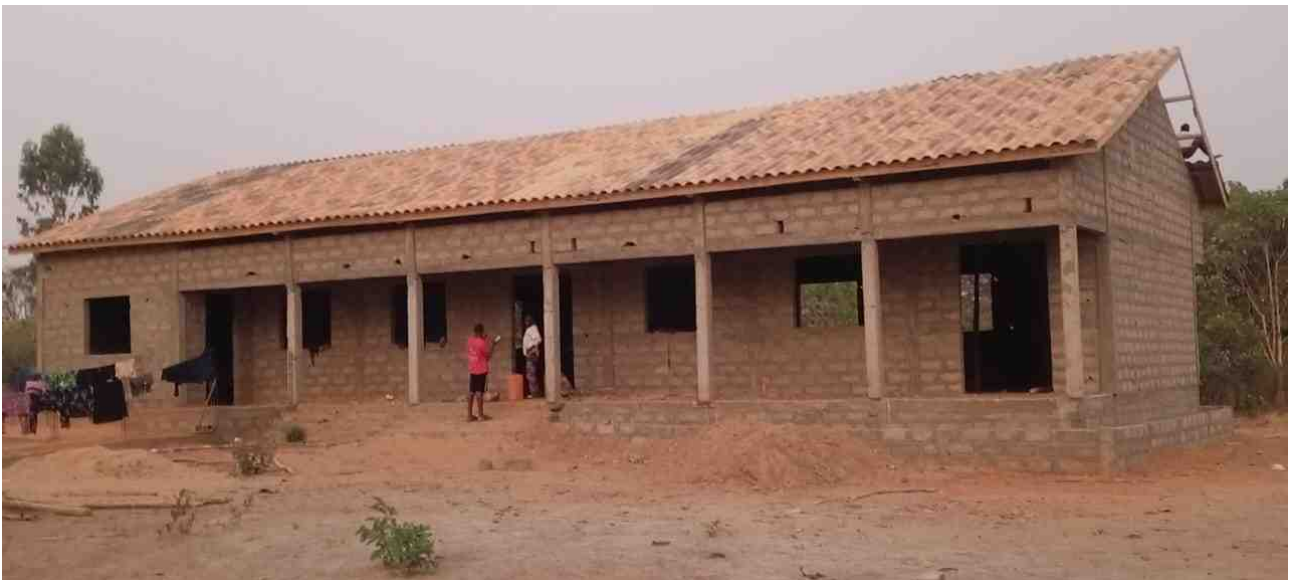
The cross ties have been made.
